Mercedes-Benz OC500LE MCV Evolution C124RLE

Somerbus bought this unregistered MCV Evolution C124RLE Mercedes-Benz OC500LE to operate commercially on its Peasedown-Bath service.

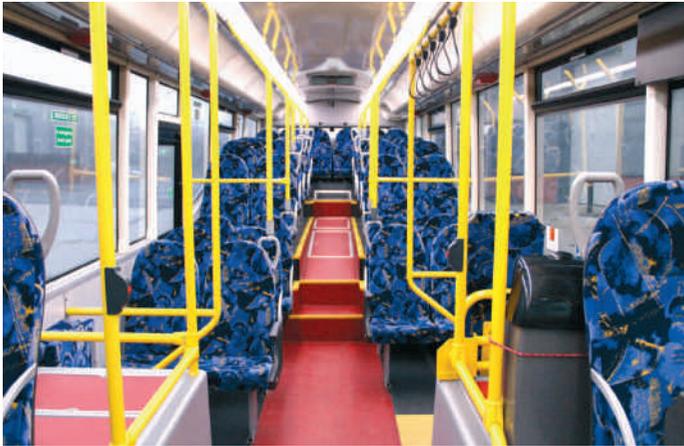
Seating for 44 is provided including four tip-ups, along with space for 26 standees. Headroom in the low floor area is 2,440mm.

Passenger capacity is 70 passengers with 40 fixed Vogel Arondo seats, including four in the rear-most row, along with four tip-ups (one on the offside and three in the nearside wheelchair bay). The standee capacity is 26. Wheelchair passengers are accommodated in a bay on the nearside immediately beyond the large wheelarch boxes, each of which has a single forward facing seat incorporated. There is an additional double

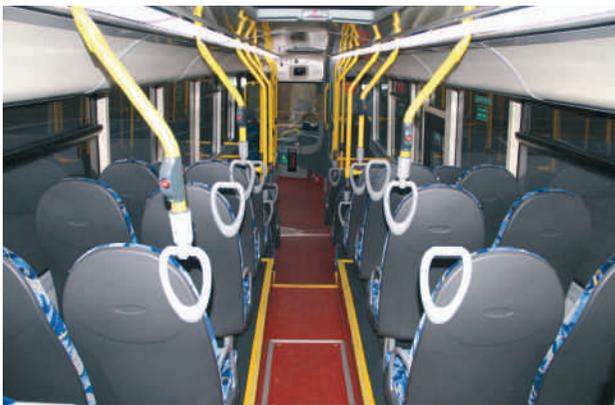
The interior from the rear, showing how the stick-on Vogel badges have all disappeared from the rear of the Vogel Arondo seats.

A slight disappointment to Tim is that the Vogel badges that were in place when the bus arrived were stuck on items that sat in an oval recess on the moulded seat back. His passengers are not prone to damaging buses but little fingers soon removed them.

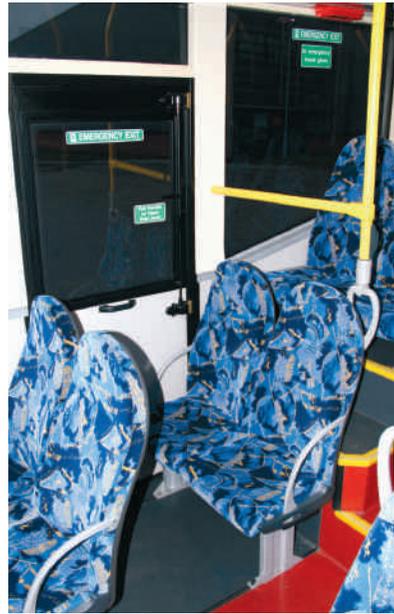
The emergency door is in the low floor area. Note the armrests on the seats.

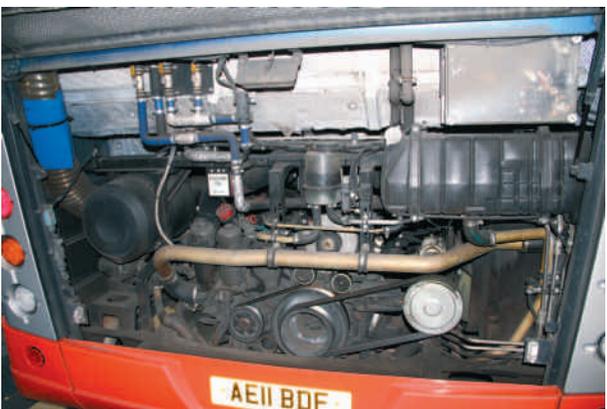
Mercedes-Benz fit the 12-litre OM457HLA horizontal six-cylinder unit in the OC500LE. It delivers 299hp (220kW) at 2,000rpm and peak torque of 1,250Nm at 1,100rpm.

Built at the former Setra Saida plant at Castro Urdiales, Northern Spain, alongside the underframe modules for the Cobus apron bus range, the OC500LE chassis features the six-cylinder OM457HLA horizontal engine. This well respected 12-litre unit delivers 299hp (220kW) at 2,000rpm and peak torque of 1,250Nm at 1,100rpm.

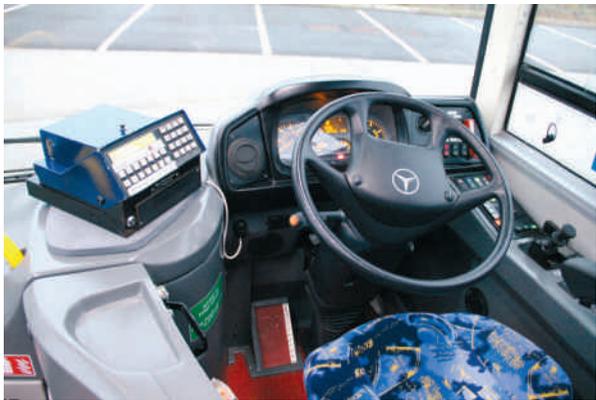
Although spacious, there were criticisms of the cab, particularly the location of the indicators which cannot easily be seen behind the steering wheel and do not always self cancel. I am told that an audible indicator warning is a Mercedes option.

summer the heat builds up and you can't get rid of it so it gets quite stuffy in the cab.' He also mentioned the indicators saying, 'if you adjust the steering wheel to where you want it for

comfort you can't see the indicators and they don't always self-cancel.' However, he did find the driver's seat comfortable.

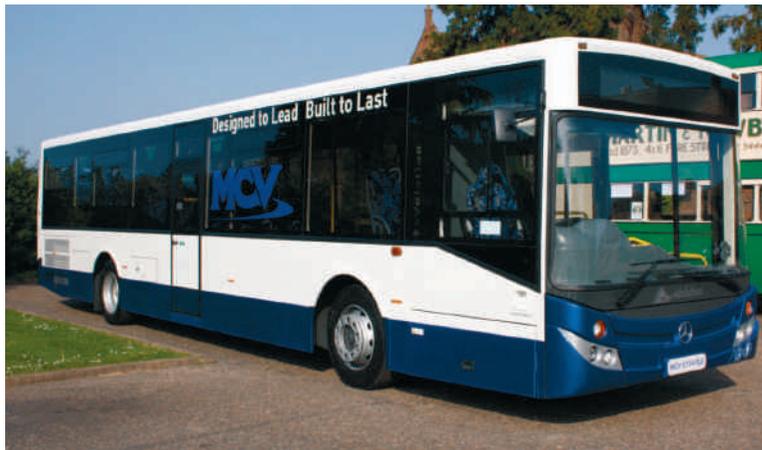
'Designed to Lead - Built to Last' said the slogan on the side when the bus was demonstrated at the ALBUM conference in Norwich in 2010. With a Cromwell frame, big engine and heavy duty componentry it should live up to the second half of the message.

Construction of the body is in Cromwell stainless steel and takes place in the modern plant at Salheya in Egypt in accordance with the

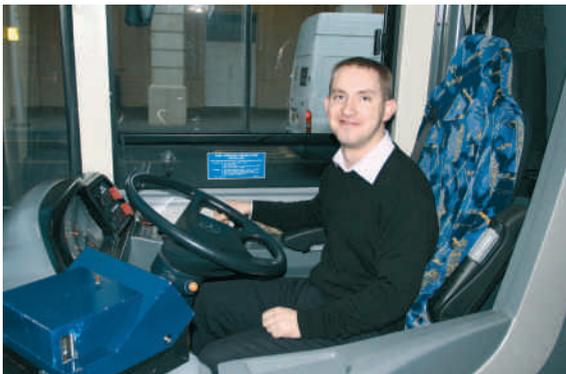
John Levy in the process of taking over from Tim for the return run from Bath. Note the moquette trimmed Grammer driver's seat.

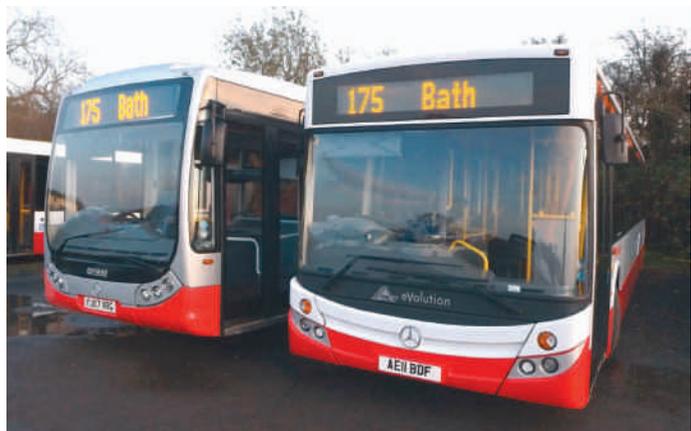
The Mercedes-Benz OC500LE replaced a 12.6m Optare Tempo which had been delivering 7.9mpg on the same route.

From entering service in July to mid November it has covered 17,130 miles and returned an average of 7.42mpg which Tim considers acceptable for a heavyweight on a hilly route. In comparison the longer Tempo, which was around 1.5-tonnes lighter, returned an average of 7.9mpg over the course of a year.
